INCORPORATION OF CULTURAL FUNCTIONS IN ARCHITECTURAL ADAPTATION FROM TRADITIONAL HISTORIC BUILDINGS INTO ART GALLERIES IN SKOPJE, N. MACEDONIA

Associate Professor PhD. Sc Viktorija Mangaroska

International Balkan University, Faculty of Engineering / Architecture

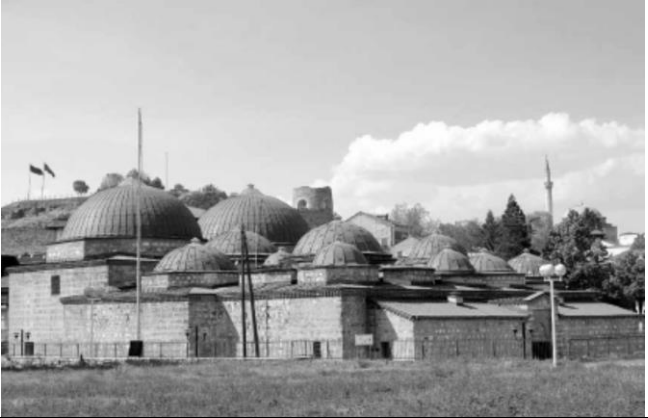
<p>2.1 Daut Pashin Hammam, Skopje Macedonia</p>

<p>Location</p>	<p>Daut Pashin Hammam is located just near the Stone Bridge on the right when standing at the entrance of the Old Bazaar.</p>
<p>Historic Period</p>	<p>It is presumed to have been built in the second half of the 15th century and the founded by the great vizier Daut Pasha who held highest rank in the hierarchy of the Ottoman Empire.</p>
<p>Architectural Type</p>	<p>The hammam belongs to the cifte type of double baths - hammams. It was divided in two parts men's and women's with separate entrances.</p> <p>Daut Pashin Hammam has capacity of twelve rooms. It is covered with a large number of domes with different dimensions with fascinating asymmetric and rhythmical arrangement. The domes have rich decoration which consists of stalactite ornaments. In some of the rooms, decoration in</p>

<p>the shape of a frieze with stylized flowers carved in low relief can be seen in fragments on the walls. Its dimensions and aesthetic values make it a masterpiece of profane Islamic architecture.</p>

<p>Damages over historic periods</p>	<p>This hamam suffered heavy damages in wars, natural disasters, the earthquake of 1555, the fire set to Skopje by Piccolomini in 1689 and the earthquake of 1963.</p>
<p>Function and Re-use</p>	<p>In the past this building was used as a public bath, and since it's restoration in 1948, it serves as an exhibition facility and Art Gallery. Today's permanent exhibition was formed in 2000 with exhibitions of development of Macedonian visual arts from 14th to 20th century</p>

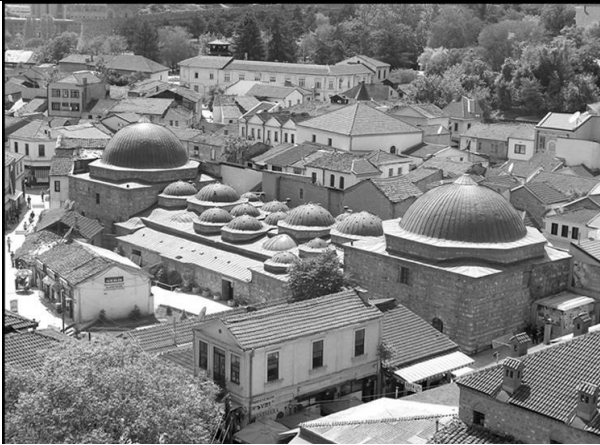
<p>2.2 Cifte Hammam, Skopje Macedonia</p>

<p>Location</p>	<p>Cifte Hammam is located in the immediate vicinity of Suli Inn in the Old Bazaar in Skopje</p>	
<p>Historic Period</p>	<p>Cifte Hammam was built in mid-15th century and is the second-largest hammam from this period, built by Isa Bey in 1531.</p>	
<p>Architectural Type</p>	<p>The hammam belongs to the cifte type of double baths - hammams. It was divided in two parts men's and women's with separate entrances.</p> <p>The main rooms are covered with two large domes, while the halvets (bathing cubicles) and other chambers are vaulted with a large number of small domes, today covered with sheet metal.</p> <p>The organization and arrangement of the rooms in both parts is typical and depends on their purpose: the anteroom (meydan or şadrvan) which was intended for relaxation, partially warmed room (kapaluk), bathing space (halvet). Today, the stylized geometric and vegetative ornaments, stalactites and rhombuses rendered with great precision in low relief survive only in fragments in some of the halvets.</p>

<p>Damages over historic periods</p>	<p>Cifte Hamam was damaged several times: in the earthquake which struck the Skopje region in 1555, and during the great fire in the 17th century when the structure was damaged.</p> <p>Its full conservation began after the earthquake of 1963, when the bath suffered more extensive damage. Due to the fact that it was solidly built, the hammam mainly preserved its original appearance.</p>	
<p>Function and Re-use</p>	<p>Cifte Hamam in 1916 had a function of a storage space. Today it is the site of the National Art Gallery in Macedonia.</p> <p>In the past this building was used as a public bath, and since it's restoration in 2002 Cifte Hammam was reopened as a National Gallery, with exhibition area measured of 1056 sq.m.</p>	
<p>Preservation Project</p>	<p>New preservation project has started in Cifte Hammam from 2018, which included basic project for remediation of damages from moisture, protection from storm water, ventilation system of interior, protection of UV radiation and repair of the roof construction, conversion of the premises into functional exhibition space, repair of lighting installation. All of the preservation activities of the facility had to be carried out according to the standards and norms from the Conservation approval for repair from the Institute for protection of cultural heritage.</p>

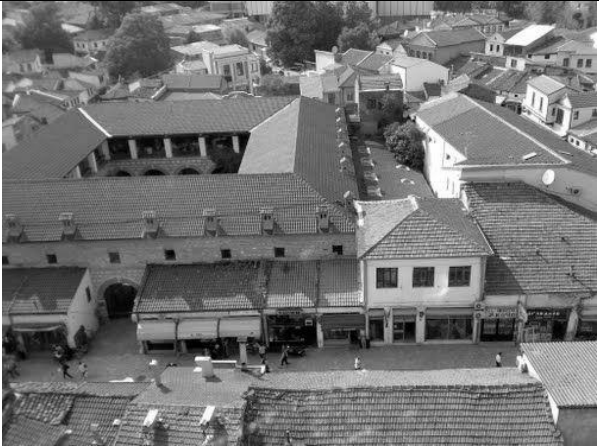
<p>2.3 Suli Inn, Skopje Macedonia</p>

<p>Location</p>	<p>Located at the heart of the Old Bazaar in Skopje</p>	
<p>Historic Period</p>	<p>Suli Inn was built in the 15th century by Isa-bey</p>	
<p>Architectural Type</p>	<p>Suli Inn belongs to the type of two-storey inns with an open square courtyard, surrounded with a porch supported by massive square columns. There are twenty-seven rooms on the ground floor, and thirty rooms with chimneys to keep the visitors warm on the upper floor which served for overnight stay of the travelers. It is built with stone and brick in opus-cloisonné style. Suli Inn represents an important work of profane Ottoman architecture.</p>

<p>Damages over historic periods</p>	<p>In its history, the inn was damaged several times: in the earthquake of 1555 and in the fire of 1689 when the Austrian general Piccolomini set the city of Skopje on fire, and when it was heavily damaged; after these disasters, the inn was reconstructed. In the earthquake of 1963 it was almost completely destroyed, but after its conservation and restoration, it acquired its present-day appearance.</p>

<p>Function and Re-use</p>	<p>It lost its function in the late 19th century; in the period that followed, it served as a warehouse and the site of several craft shops. Today in Suli Inn is located Faculty of Fine Arts, the Gallery of Contemporary Art, as well as of the Old Bazaar opened in 1983 which holds various ceramic works and artworks with motives of the old town, as a unit of the Skopje City Museum.</p>
